# A STUDY OF FATIGUE DAMAGE IN ASPHALT PAVEMENT BASED ON REMOTE SENSING

Dept. of Civil Engineering

Alva's institute of engineering and technology, Mangalore, INDIA.

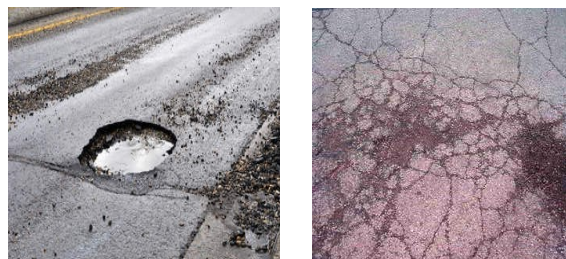
**Figure 1: Asphalt pavement defects (a) Potholes (b) Cracks**

Asphalt pavements gets deteriorated with time due to aging, erosion, oxidation, loss of oily components causing structural damages and changes in the material composition. In order to have safe and operational Asphalt roads, the distresses such as ravelling, flushing, polishing, distortion, cracks, patches and potholes have to be monitor and rectified regularly by the local authorities and agencies. [2]

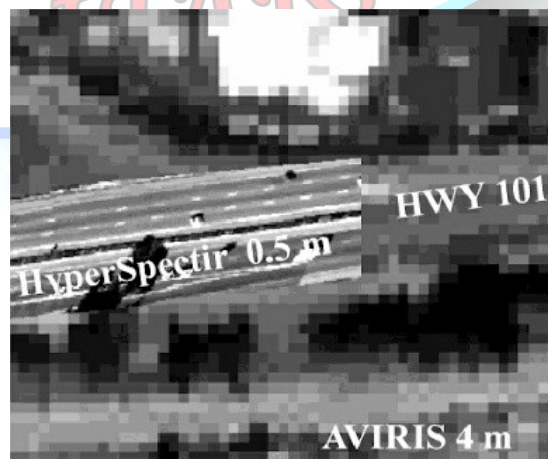
**Figure 3: Visual different between hyperspectir (0.5 m) and AVIRIS (4 m) data emphasizing expected limitations due the spatial resolution configurations.**

The exploration of remote sensing mapping capabilities assessed with different spatial resolutions (AVIRIS data – 4 m; HyperSpectir – 0.5 m) two imaging spectrometers. The study used a band difference in the visible region (spectral difference between the bands at 830 nm and 490 nm - VIS2-difference) and the local spatial variance to compare in-situ pavement performance observations to remote sensing signals. Fine spatial resolutions are essential for the mapping of road deterioration. The condition observation (fig 3) says GIFOV

should be finer than 4 m and potentially as fine as 0.5 m for detailed road. The Pavement Condition Index - PCI ( $R^2 = 0.63$ ) is compared to reflectance difference of the HyperSpectir data and showed that imaging spectrometry has potential for representing road conditions (fig 4). The link between the PCI and remote sensing signal (image band difference) is strong for roads in good conditions but declines for lower quality roads. Roads could be discriminated from those that required no management action to roads that do. Currently, the algorithm is not able to discriminate between management actions (i.e., maintenance versus rehabilitation).

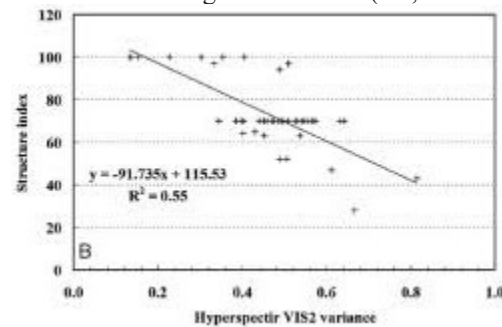
**Figure 4: Comparison between Hyper spectral VIS2 contrast esteems and the Road product Pavement Condition Index (PCI).**
